CULTURAL RESOURCE SURVEY  
MAIN BUILDING FORM

CRS # K-2726

1. HISTORIC NAME/FUNCTION: W. Townsend Farm/Farm
2. ADDRESS/LOCATION: 6961 Bay Road, West Side of SR 1 Near Barrett's Chapel
3. CURRENT CONDITION:    excellent ☐    good ☒    fair ☐    poor ☐    demolished ☐
4. INTEGRITY: The house has vinyl siding; the porch deck has been rebuilt; most of the previous outbuildings have been razed and/or replaced.
5. SETTING INTEGRITY: Good; it is still surrounded by agricultural lands.

### **Townsend Farm**

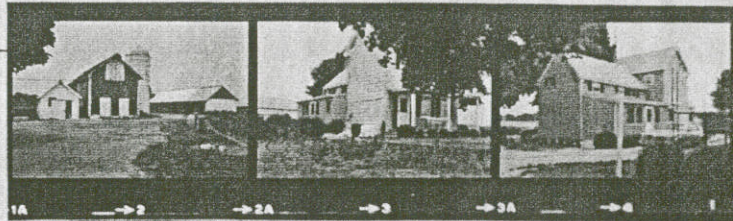
CRS Number K-2726 Date 8-80 Contact Sheet # C-1259

Description 2) barn 3) Lside 4) Lside 5) outbuildings

6) back 7) outbuilding

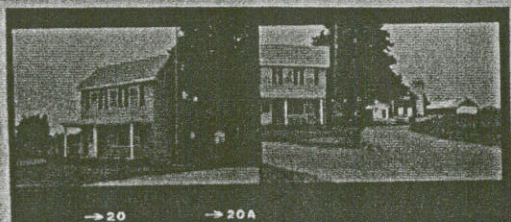
CRS Number K-2726 Date 8-80 Contact Sheet # C-1258

Description 20) 3/4 front & R side -) house & outbuildings

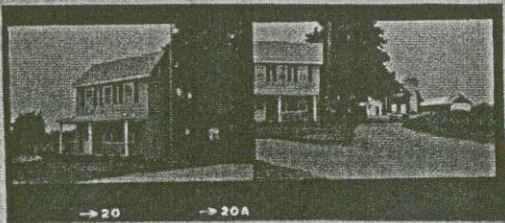
CRS Number K-2726 Date 8-80 Contact Sheet # C-1258

Description 20) 3/4 front & R side -) house & outbuildings

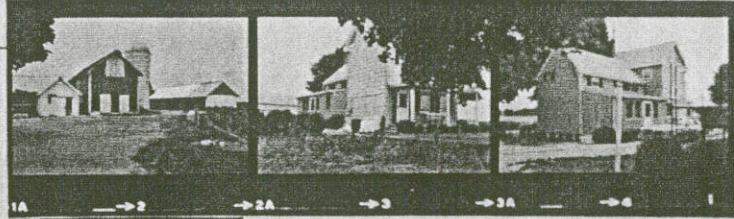
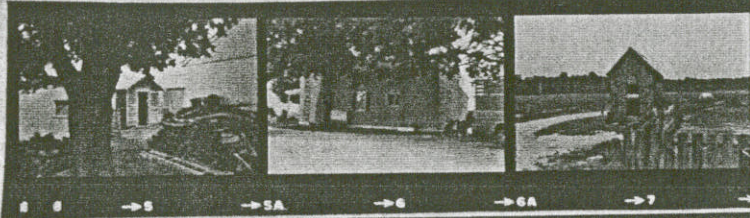
CRS Number K-2726 Date 8-80 Contact Sheet # C-1259

Description 2) barn 3) L side 4) L side 5) outbuildings  
6) back 7) outbuilding
